# Manhole Inspection Summary

Manhole # S35II\_050MH

Insp Date: **3/13/07 9:07 AM**

**Location** Address: **1633 CALVERT ST**

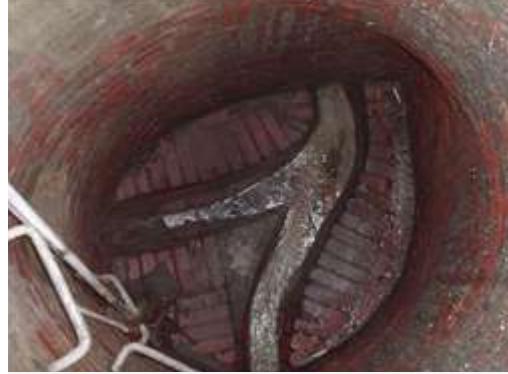
Top View

Corroded steps. Bench and Channel debris.

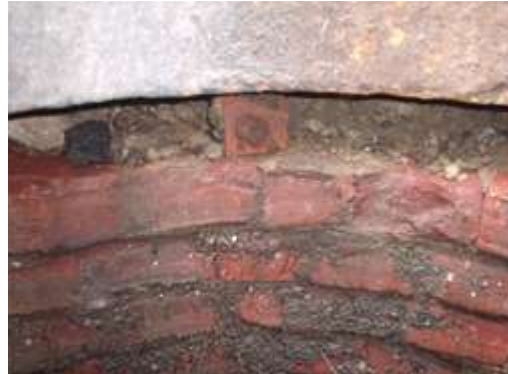
Defect

Frame leaks. Adjustment deterioration and infiltration.

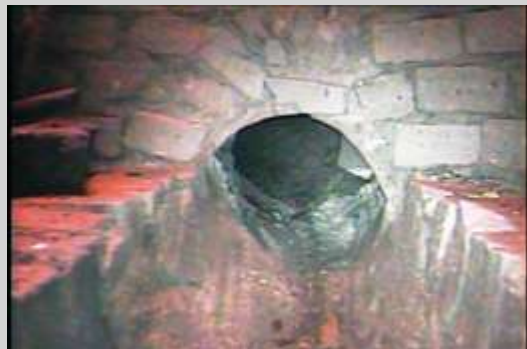
Pipe In @ 9 O'Clock

Deposits: ☐ None ☒ **Mud** ☐ Sludge ☒ **Debris** ☒ **Grease**

Deposits Extent: **Light**

Pipe Seal Cond: **Roots**
